# Sensitivity of RadCalc EPID Dosimetry for In Vivo Composite Dose Evaluation

This study is designed to test the sensitivity of the RadCalc EPID Dosimetry Suite using a heterogeneous Easy Cube phantom in a full body configuration, from LAP.

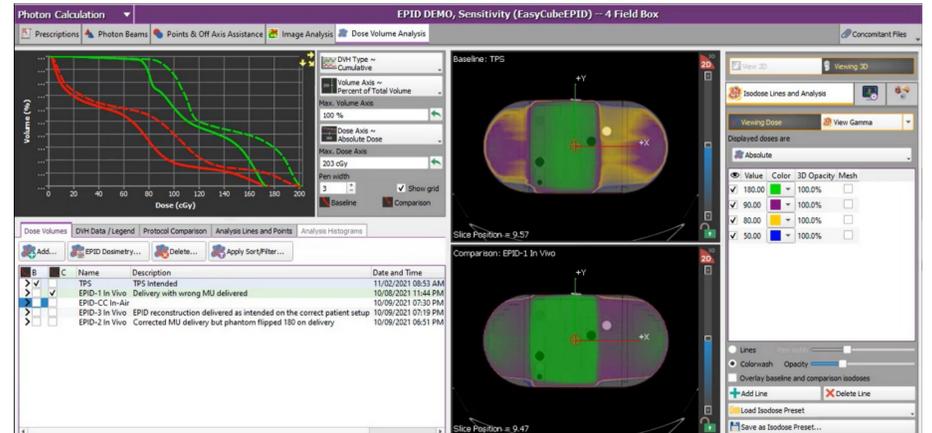
Figure 1: The calculation of the delivery with erroneous Monitor Unit, showing DVH and dose in colorwash.

In the first calculation, illustrated in **Figure 1**, the lateral monitor units were incorrect, here the DVH clearly indicates an issue from the incorrect monitor units. This difference is also seen in the dose colorwash. The corresponding Gamma analysis results show only 25.2% of voxels passing, as seen in **Figure 2**.

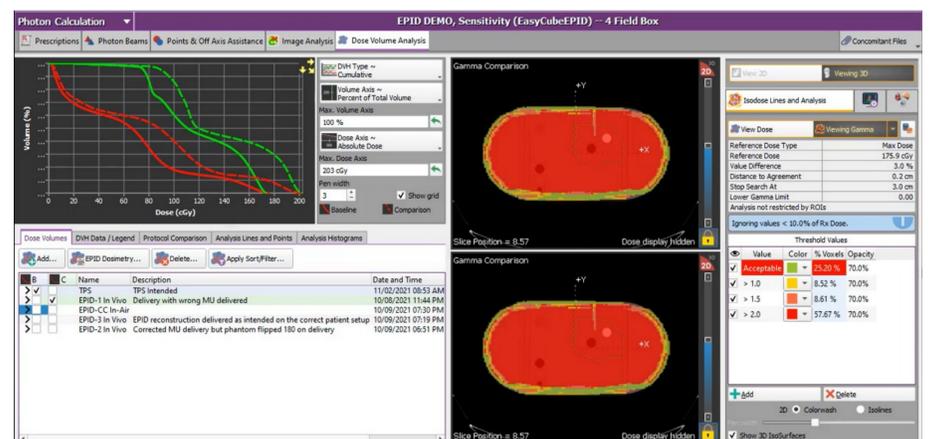
Figure 2: The Gamma analysis of the delivery with erroneous Monitor Units.

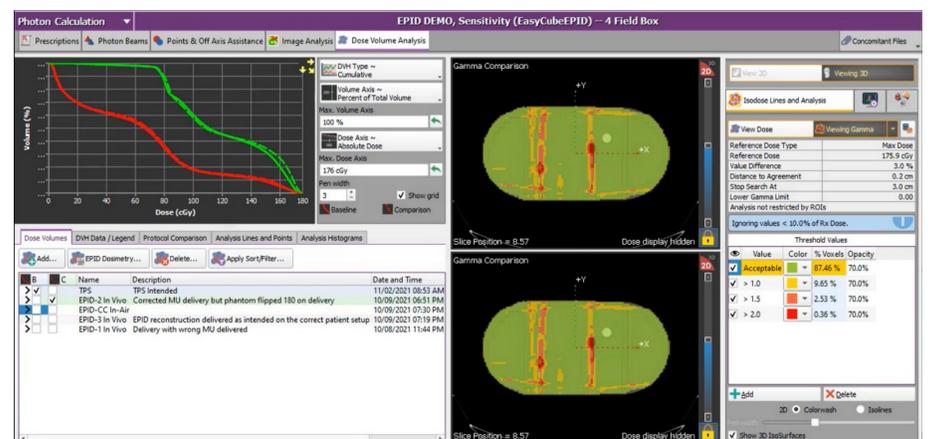
Figure 3: The delivery with correct Monitor Units and flipped 180 degrees.

The second calculation, illustrated in **Figure 3**, has the correct monitor units delivered, the plan is recalculated, and the DVH comparison improves significantly. However, the sensitivity of the flipped phantom shows up as demonstrated by the DVH discrepancies and the unique areas of gamma failures around the introduced heterogeneities, demonstrating the sensitivity in expected anatomical densities. Additionally, the pass rate is still below 90%.

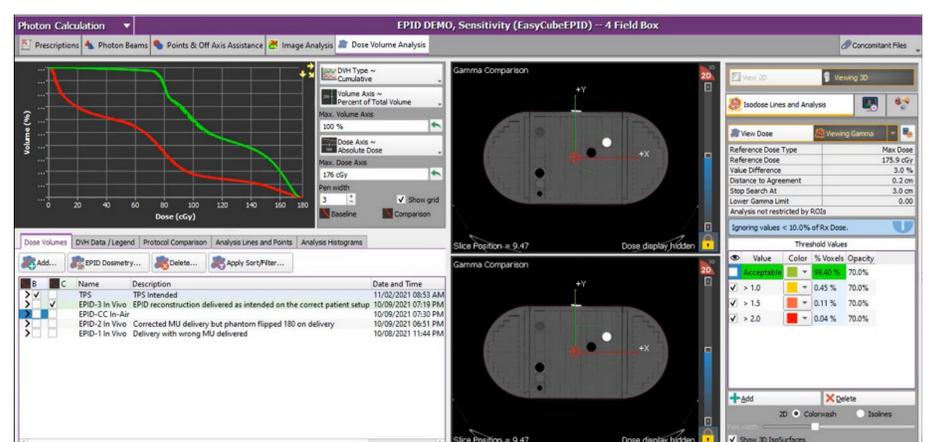
Figure 4: The delivery was performed as intended.

In the third calculation as seen in **Figure 4**, the treatment was performed as intended and we see the DVH match very well and a gamma passing rate of 99.4%.
